**Flood Control Project Maintenance  
Levee Inspections**

**Fall 2016 Levee Maintenance Deficiency Summary Report**

**Sacramento River Basin**

**Sutter Maintenance Yard Maintenance Area 0013**

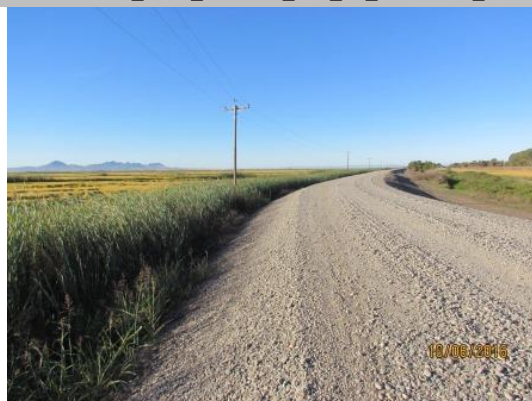
Photo 1 of 1 : FA\_2016\_MA0013\_301\_60\_20161014\_00105.jpg

LM Start	15.37	Rating **	M	Issue No.	60
LM End	15.37	Issue Type +	Ma	Location *	LS
Category	Earthen Levee			GPS Latitude/Longitude	
				Start	End
Item	Vegetation			39.419957 °	39.419957 °
				-121.772700 °	-121.772700 °
DWR ID	DWR_MA0013_02_f_2016_60				
Comment Code					
V2 : Remove the wild growth other than native grasses from the levee slopes.					
Inspector Comment					
Tules on the landside toe.

View of dense tules along the landside toe.

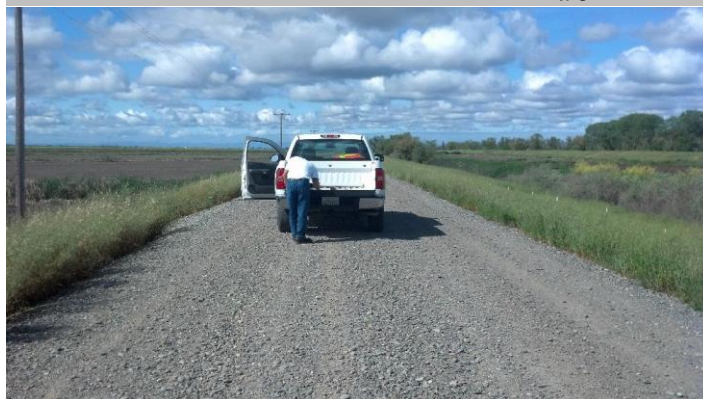
Photo 1 of 2 : UCIP\_FA\_2016\_48066\_67341.jpg

FS\_ID:48066  
DS\_ID:16376  
EP\_NO: N/A  
Repair Type: Non-Urgent  
Crossing Status: Found  
UCIP Comments: 4/26/2016 LS inlet appears to be buried as could not locate it. WS flap gate was bolted shut. This appears to be an abandoned crossing. 6/30/2015 Still unable to locate the LS pipe end.

Overview of crossing looking downstream at the left bank of Cherokee Canal.

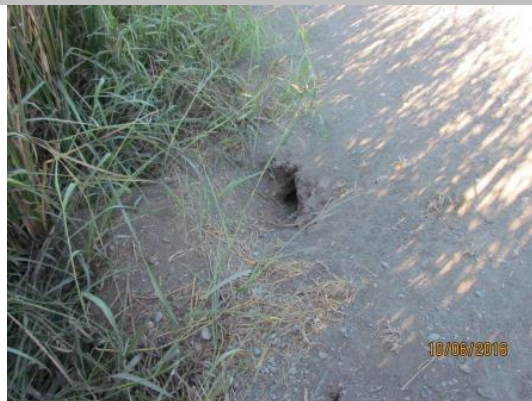
Photo 1 of 1 : FA\_2016\_MA0013\_301\_63\_20161014\_00106.jpg

LM Start	15.63	Rating **	M	Issue No.	63
LM End	15.63	Issue Type +	Ma	Location *	LS
Category	Earthen Levee			GPS Latitude/Longitude	
				Start	End
Item	Animal Control			39.417470°	39.417470°
				-121.776559°	-121.776559°
DWR ID	DWR_MA0013_02_f_2016_63				
Comment Code					
A3 : No rodents visible, but rodent burrows visible; need to backfill and compact or grout burrows.					
Inspector Comment

View of the rodent holes along the landside slope.

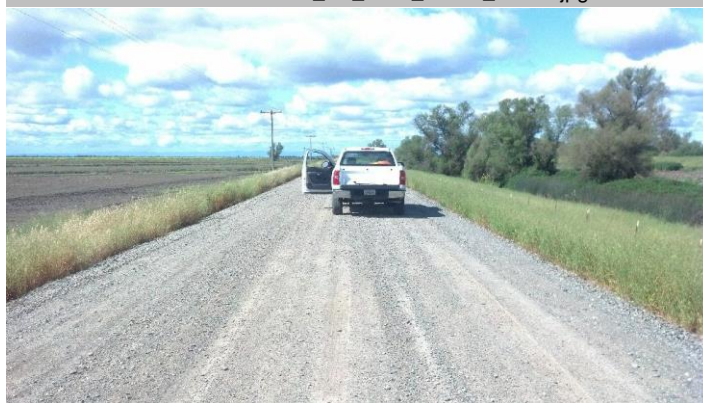
Photo 1 of 2 : UCIP\_FA\_2016\_47751\_67352.jpg

Comment Code					
Inspector Comment					
FS_ID:47751 DS_ID:16382 EP_NO: N/A Repair Type: Non-Urgent Crossing Status: Found UCIP Comments: 4/26/2016 Appears to be an abandoned crossing. LS pipe end was still buried and WS flap gate was bolted shut.6/30/2015 LS headwall stil buried somewhere. WS looked to be in good condition.5/28/2014 Same as last inspection.12/4/2013 Same as last inspection.7/08/2013 Same as last inspection.4/24/2012 LS headwall buried. Limited inspection on WS and LS slopes due to dense vegetation. Need photos of cleared WS and LS slopes during next inspection. Need to determine the fate of LS headwall. This crossing was listed in the USACE Periodic Inspection report as Corp's inspect ID# USACE_CESPK_M13E_2011_p_0022 -- unknown issue. FIELD_STRUCT_DESC: *ABANDONED* 24-inch corrugated metal drainage pipe through the levee, 9 feet below the crown. Flap gate located on the waterside (WS) end. Concrete "U" headwalls on both WS and landside (LS). WS gate bolted shut and LS crossing is non-operable (inlet not found). Additional Reference(s): DWR Levee Log, 1993. USACE Sacramento O&M Manual 519, June 1962 (HLM 15.87)] FS Date: 5/3/2016 2:32:00 PM

Overview of crossing looking downstream of the left bank of Cherokee

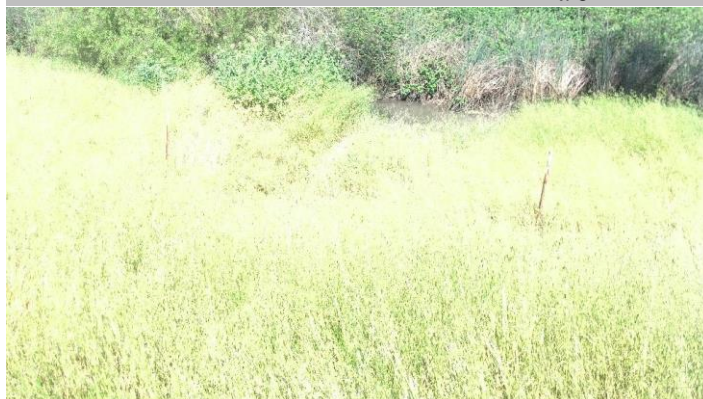
Photo 2 of 2 : UCIP\_FA\_2016\_47751\_67351.jpg

View of WS slope. Limited inspection due to the dense vegetation.

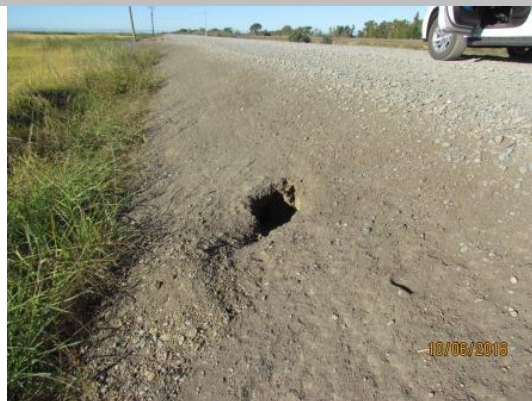
Photo 1 of 1 : FA\_2016\_MA0013\_301\_64\_20161014\_00107.jpg

LM Start	15.98	Rating **	U	Issue No.	64
LM End	15.98	Issue Type +	Ma	Location *	LS
Category	Earthen Levee			GPS Latitude/Longitude	
				Start	End
Item	Animal Control			39.414397 °	39.414397 °
				-121.781596 °	-121.781596 °
DWR ID	DWR_MA0013_02_f_2016_64				
Comment Code					
A3 : No rodents visible, but rodent burrows visible; need to backfill and compact or grout burrows.					
Inspector Comment

View of the rodent holes along the landside slope.

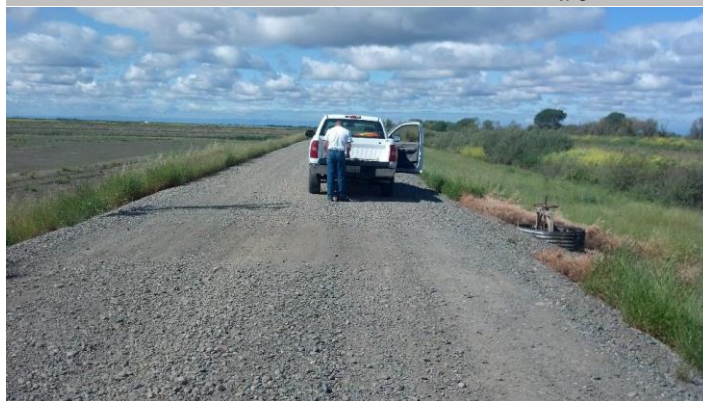
Photo 1 of 2 : UCIP\_FA\_2016\_47752\_67353.jpg

FS\_ID:47752  
DS\_ID:16377  
EP\_NO: N/A  
Repair Type: Non-Urgent  
Crossing Status: Found  
UCIP Comments: 4/26/2016 LS headwall was dry and photographed. LS pipe end was about 50% plugged with soil. WS riser box is still cracked and appears to still be leaking.6/30/2015 Bee boxes stacked near the riser box on WS so could not get close enough to see if the leak issue had been fixed. 5/28/2014 Water appears to be leaking out of the WS concrete riser box. Causing minor erosion under pipe near pump structure.12/4/2013 Same as last inspection.7/08/2013 LS slope has been cleared of vegetation and is in good condition. LS headwall was underwater and unable to be inspected. All WS appurtances in good condition.4/24/2012 Limited inspection on LS slope due to dense vegetation. Need photos of cleared LS slope and LS headwall. Cracks in riser box. New pump installed recently this work might be covered under sepearte permit.

Overview of levee crown.

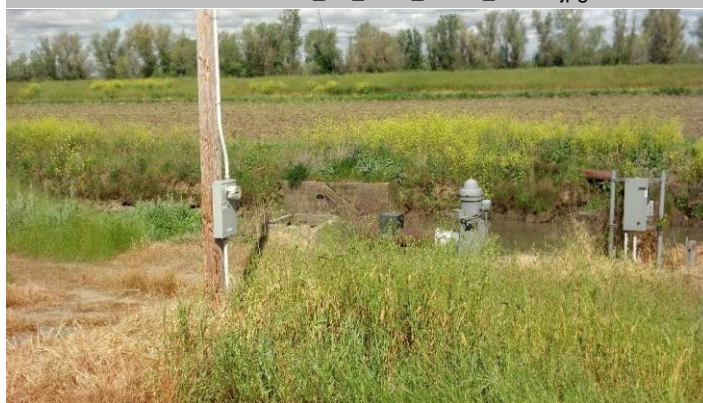
Photo 2 of 2 : UCIP\_FA\_2016\_47752\_67359.jpg

Appurtenances on WS.

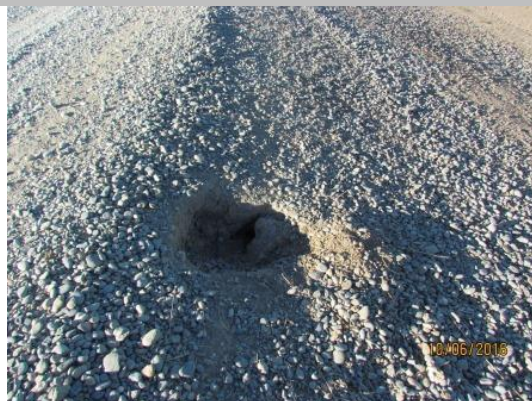
Photo 1 of 1 : FA\_2016\_MA0013\_301\_54\_20161014\_00108.jpg

LM Start	16.52	Rating **	U	Issue No.	54
LM End	16.52	Issue Type +	Ma	Location *	WS
Category	Earthen Levee			GPS Latitude/Longitude	
				Start	End
Item	Animal Control			39.409548 °	39.409548 °
				-121.789668 °	-121.789668 °
DWR ID	DWR_MA0013_02_f_2014_54				
Comment Code					
A3 : No rodents visible, but rodent burrows visible; need to backfill and compact or grout burrows.					
Inspector Comment

View of the rodent holes along the waterside slope.

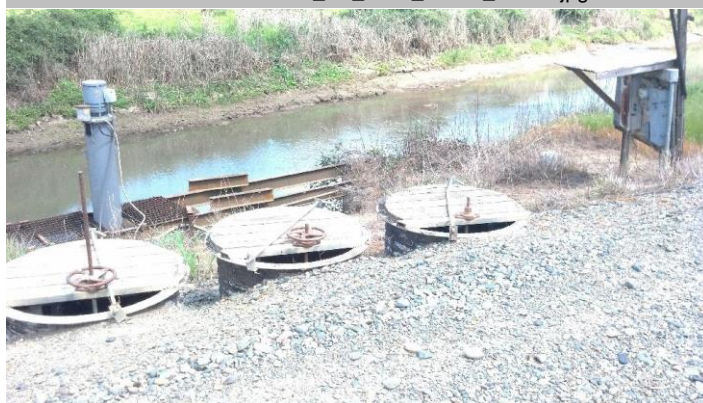
Photo 1 of 2 : UCIP\_FA\_2016\_49926\_67406.jpg

UCIP Comments: 4/26/2016 No repairs have been made at this crossing yet. (DWR Sutter Yard - afreitag)6/30/2015 Crossing has not been repaired yet. pipe ends still showing heavy signs of rust and corrosion. (DWR Sutter Yard - afreitag)5/28/2014 Same as last inspection. (DWR Sutter Yard - afreitag)12/4/2013 Same as last inspection. (DWR Sutter Yard - afreitag)7/8/2013 Same as last inspection. (DWR Sutter Yard - afreitag)4/19/2012 LS pipe collars severely damaged--section missing at flapgate. Buried section of pipe could be in the same condition. Crossing needs to be repaired; will need to coordinate with applicant. WS slide gate handle missing. (DWR UCIP - omagana)

Corrugated metal pipe risers with slide gates located on WS slope.

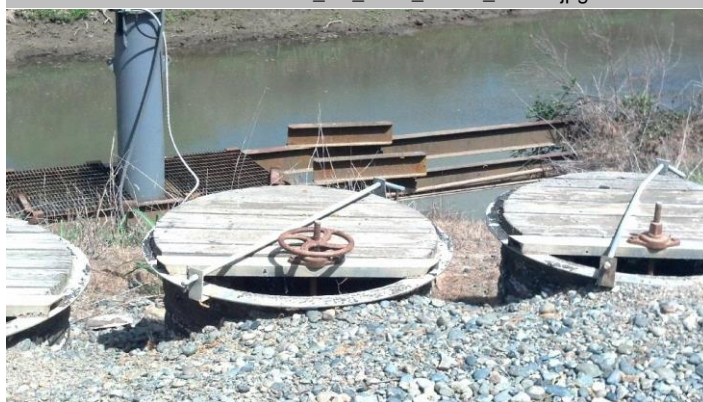
Photo 2 of 2 : UCIP\_FA\_2016\_49927\_67418.jpg

FS\_ID:49927  
DS\_ID:17014  
EP\_NO: N/A  
Repair Type: Urgent  
Crossing Status: Found  
UCIP Comments: 4/26/2016 No repairs have been made at this crossing yet. (DWR Sutter Yard - afreitag)6/30/2015 Crossing has not been repaired yet. pipe ends still showing heavy signs of rust and corrosion. (DWR Sutter Yard - afreitag)5/28/2014 Same as last inspection. (DWR Sutter Yard - afreitag)12/4/2013 Same as last inspection. (DWR Sutter Yard - afreitag)7/08/2013 Same as last inspection. (DWR Sutter Yard - afreitag)4/24/2012 LS pipe collars severely damaged--section missing at flapgate. Crossing needs repair. Will need to coordinate with owner. (DWR UCIP - omagana)  
FIELD\_STRUCT\_DESC: 2 of 3: 16-inch steel irrigation pipe encased in reinforced concrete through the levee, 9.7 feet below the crown. Concrete "U" headwall on both ends. Slide gates on corrugated metal pipe risers on the waterside (WS) slope. Pump structure on the WS end. [Additional Reference(s): DWR Levee Log, 1993. USACE Sacramento O&M Manual 519, June 1962 (HLM 21.00)]

Riser for pipe 2 of 3.

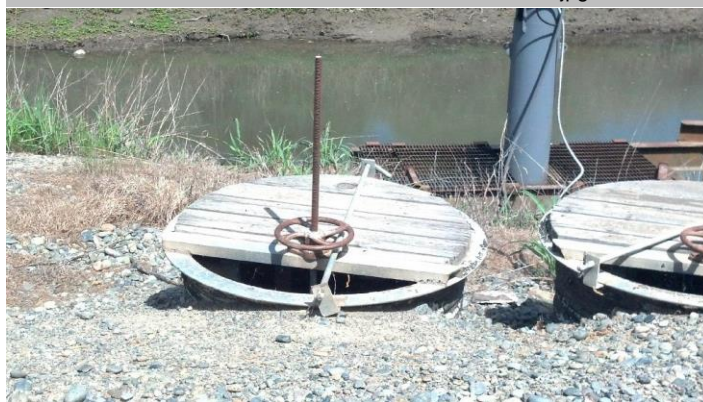
Photo 2 of 2 : UCIP\_FA\_2016\_49928\_67443.jpg

FS\_ID:49928  
DS\_ID:17185  
EP\_NO: N/A  
Repair Type: Urgent  
Crossing Status: Found  
UCIP Comments: 4/26/2016 No repairs have been made at this crossing yet. (DWR Sutter Yard - afreitag)6/30/2015 Crossing has not been repaired yet. pipe ends still showing heavy signs of rust and corrosion. (DWR Sutter Yard - afreitag)5/28/2014 Same as last inspection. (DWR Sutter Yard - afreitag)12/4/2013 Same as last inspection. (DWR Sutter Yard - afreitag)7/08/2013 Same as last inspection. (DWR Sutter Yard - afreitag)4/24/2012 Sink hole present on WS. LS pipe collars severely damaged--section missing at flapgate. Crossing needs repair. Need to coordinate with owner. (DWR UCIP - omagana)  
FIELD\_STRUCT\_DESC: 3 of 3: 16-inch steel irrigation pipe encased in reinforced concrete through the levee, 9.7 feet below the crown. Concrete "U" headwall on both ends. Slide gates in corrugated metal pipe risers on the waterside (WS) slope. Pump structure located on the WS end. [Additional Reference(s): DWR Levee Log, 1993. USACE Sacramento O&M Manual 519, June 1962 (HLM 21.00)]

View of corrugated metal pipe for pipe 3 of 3.

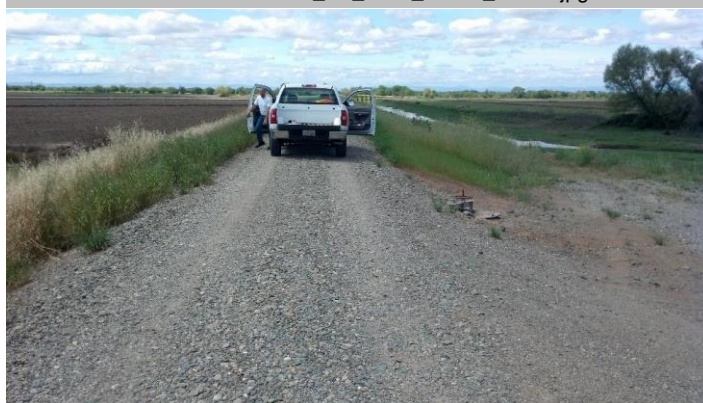
Photo 1 of 2 : UCIP\_FA\_2016\_48493\_67447.jpg

Comment Code					
Inspector Comment					
FS_ID:48493 DS_ID:16384 EP_NO: N/A Repair Type: Non-Urgent Crossing Status: Found UCIP Comments: 4/26/2016 Pipe appears to have been repaired. Not sure on the extent of the repairs or if they were approved by the Central Valley Flood Control Board.6/30/2015 Pipe is currently undergoing repairs. Not sure what all is planed to be fixed but will update the photos and inspection report with new details when its completed.5/28/2014 Same as last inspection.12/4/2013 Same as last inspection.7/08/2013 Pipe appears to have been repaired. Need to talk to inspections and supervisor to find out more deatils on repair.4/24/2012 Needs repair. Internal piping, severe corrosion. Debris present--rusted pipe stockpiled on LS slope. Limited inspection on WS and LS slopes due to dense vegetation. Need photos of cleared WS & LS slopes. This crossing was listed in the USACE Periodic Inspection report as Corp's inspect ID# USACE_CESPK_M13E_2011_p_0234 for no WS gate but sluice gate present. FIELD_STRUCT_DESC: 24-inch corrugated metal drainage pipe through the levee, 8.2 feet below the crown. Crossing penetrates levee at angle. Slide gate in corrugated metal pipe (CMP) riser on the waterside (WS) slope. Pipe crosses the channel. Corroded section of exisiting pipe, 9-foot and 8-inch of an 18-inch corrugated metal pipe section, was replaced under Permit 7231 prior to 1974. (Permit No. 7231, 1960 - Estate of Walter L. King) [Additional Reference(s): DWR Levee Log, 1993. USACE Sacramento O&M Manual 519, June 1962 (HLM 21.60)] FS Date: 5/26/2016 7:31:43 AM

Overview of crossing looking downstream.

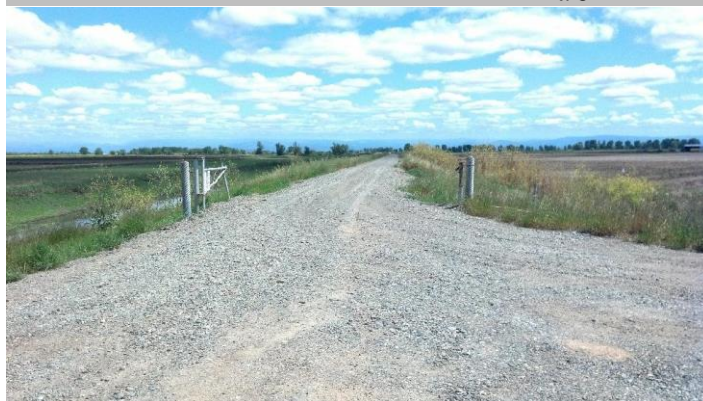
Photo 1 of 2 : UCIP\_FA\_2016\_48036\_67462.jpg

FS\_ID:48036  
DS\_ID:16394  
EP\_NO: N/A  
Repair Type: Non-Urgent  
Crossing Status: Found  
UCIP Comments: 4/26/2016 WS flap gate is really rusted and deteriorated. May need to be replaced. The rest of the crossing appeared in good condition.6/30/2015 Crossing is in good condition. No noticeable issues to be reported.5/28/2014 Same as last inspection.12/4/2013 WS and LS slopes are in good condition.7/08/2013 Same as last inspection.4/24/2012 Limited inspection on WS and LS slopes due to dense vegetation. Need photos of cleared WS and LS slopes. This crossing was listed in the USACE Periodic Inspection report as Corp's inspect ID# USACE\_CESPK\_M13E\_2011\_p\_0251 for no outlet visible on WS. FIELD\_STRUCT\_DESC: 24-inch corrugated metal drainage pipe through the levee, 11.6 feet below the crown. Flap gate on the waterside (WS) end. Concrete "U" headwalls on both WS and landside (LS). Rusted gate located on the WS (gate stuck). [Additional Reference(s): DWR Levee Log, 1993. USACE Sacramento O&M Manual 519, June 1962 (HLM 22.08)]

Overview of crossing looking upstream at the left bank of Cherokee Canal.

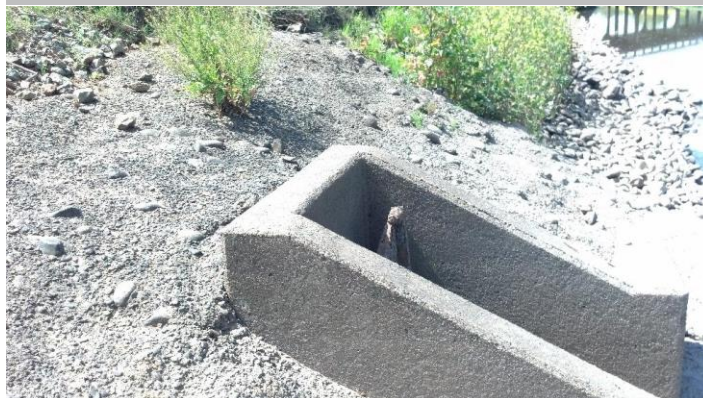
Photo 2 of 2 : UCIP\_FA\_2016\_48036\_67460.jpg

View of WS headwall.

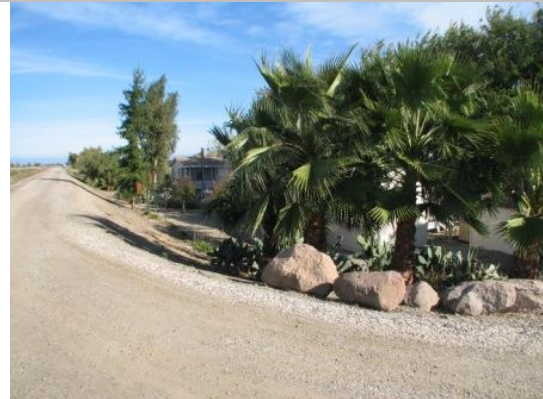
Photo 1 of 1 : FA\_2016\_MA0013\_301\_4\_20160823\_00001.jpg

LM Start	22.07	Rating **	M	Issue No.	4
LM End	22.13	Issue Type +	En	Location *	LS
Category	Earthen Levee			GPS Latitude/Longitude	
				Start	End
Item	Vegetation			39.360410 °	39.359920 °
				-121.871125 °	-121.872067 °
DWR ID	DWR_MA0013_02_s_2012_4				
Comment Code					
V6 : Landscaping					
Inspector Comment

View of landscaping along the toe.

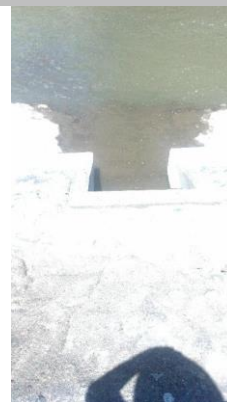
Photo 2 of 2 : UCIP\_FA\_2016\_48068\_67496.jpg

View of WS slope looking from WS headwall to levee crown.

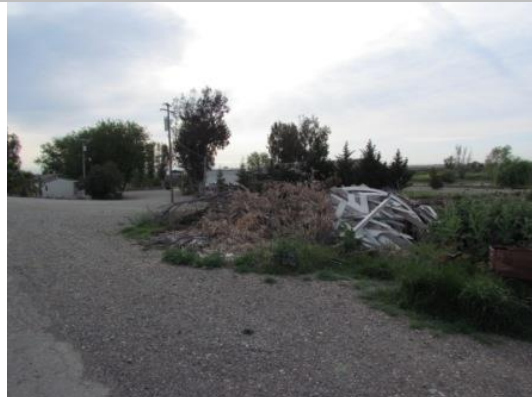
Photo 1 of 1 : FA\_2016\_MA0013\_301\_8\_20160823\_00004.jpg

LM Start	22.16	Rating **	M	Issue No.	8
LM End	22.16	Issue Type +	Ma	Location *	LS
Category	Earthen Levee			GPS Latitude/Longitude	
				Start	End
Item	Encroachments			39.359707 °	39.359707 °
				-121.872555 °	-121.872555 °
DWR ID	DWR_MA0013_02_s_2012_8				
Comment Code					
PR : Prunings					
Inspector Comment

View of the debris and prunings along the landside toe.
